Contract #: 04-0120F4Cty: SF/ALA Rte: 80 PM: 13.2/13.9File #: 69.28**WELDING INSPECTION REPORT****Resident Engineer:**Siegenthaler, Peter**Address:** 333 Burma Road**City:** Oakland, CA 94607**Report No:** WIR-021812**Date Inspected:** 13-Mar-2011**Project Name:** SAS Superstructure**OSM Arrival Time:** 700**Prime Contractor:** American Bridge/Fluor Enterprises, a JV**OSM Departure Time:** 1900**Contractor:** Zhenhua Port Machinery Company, Ltd (ZPMC), Changxing Island **Location:** Shanghai, China**CWI Name:** An Qing Xiang**CWI Present:** Yes No**Inspected CWI report:** Yes No N/A**Rod Oven in Use:** Yes No N/A**Electrode to specification:** Yes No N/A**Weld Procedures Followed:** Yes No N/A**Qualified Welders:** Yes No N/A**Verified Joint Fit-up:** Yes No N/A**Approved Drawings:** Yes No N/A**Approved WPS:** Yes No N/A**Delayed / Cancelled:** Yes No N/A**Bridge No:** 34-0006**Component:** OBG**Summary of Items Observed:**

BAY 14, OBG 14W (NWIT # 08533)

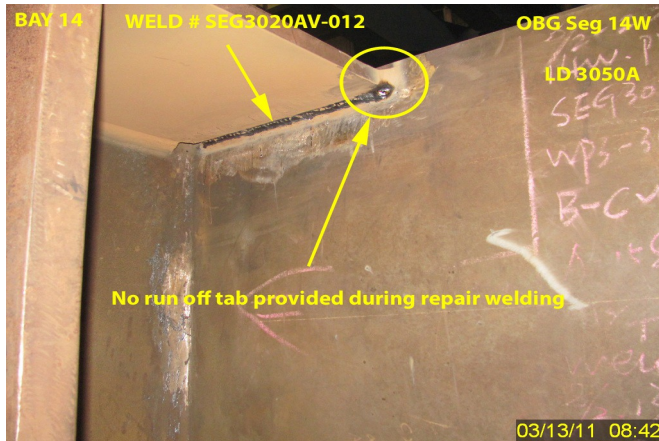
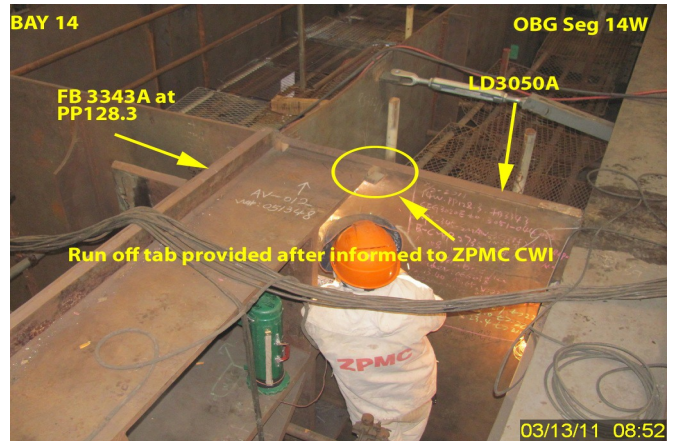
Repair welding of weld joint no: SEG3020AV-012 (Stiffener on Floor Beam (FB) 3343A to Longitudinal Diaphragm (LD) 3048A, CJP weld at Panel Point PP 128.3). The welder is identified as 051348 and was observed welding in the 4G position. Welding process was identified as Shielded Metal Arc Welding (SMAW). ZPMC CWI was identified as Mr. An Qing Xiang. The welding variables recorded by this QC appeared to comply with WPS: 345-SMAW-4G(4F)-FCM-Repair-1. Repair welding was done as per Welding Repair Report (WRR): B-WR 20393 Rev-0.

During repair welding of above mentioned weld joint, this QA inspector observed that there were no run off tabs provided at the end of the weld joint. This issue was discussed with ZPMC CWI Mr. An Qing Xiang and CT Lead QA. Mr An Qing Xiang informed the ZPMC personnel to provide the run off tabs and then start the repair work. There after this QA observed that the run off tabs were attached to the end of the weld joint while the repair work was being performed. See attached photographs for additional details.
